Manhole Inspection Summary

Manhole # S31E__039MH

Insp Date: **10/18/07 3:34 PM**

Location Address: **GREENE ST**

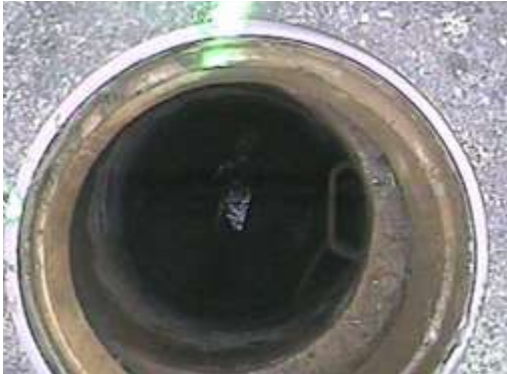
Top View

Offset: **4** (in.)

FRAME OFFSET

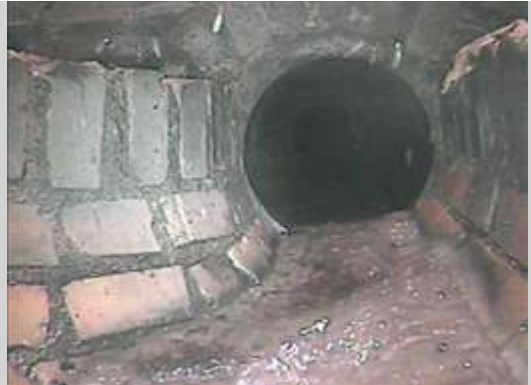
12 O'Clock Outflow

10 in. Circular Gravity Sewer
Pipe Out @ 12 O'Clock

Pipe Height: (in.) Direct
Pipe Material: **Clay** ☐ Pipe Lined
Invert Depth: **11.02** (ft.) Flow Characteristics: **Fast**
Deposits: ☒ None ☐ Mud ☐ Sludge ☐ Debris ☐ Grease
Silt Depth: (in.) Deposits Extent:
Infiltration: **None** Pipe Seal Cond: **Sound**

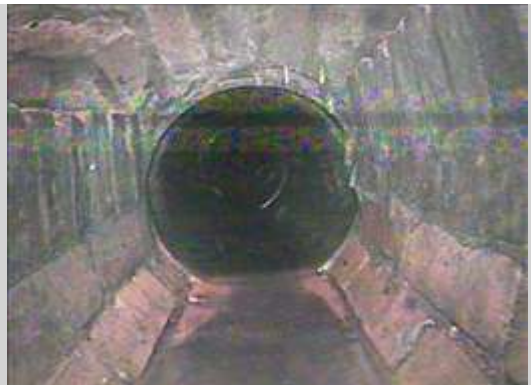
6 O'Clock Inflow

10 in. Circular Gravity Sewer
Pipe In @ 6 O'Clock

Pipe Height: (in.) Direct
Pipe Material: **Clay** ☐ Pipe Lined
Invert Depth: **10.95** (ft.) Flow Characteristics: **None**
Deposits: ☒ None ☐ Mud ☐ Sludge ☐ Debris ☐ Grease
Silt Depth: (in.) Deposits Extent:
Infiltration: **None** Pipe Seal Cond: **Sound**

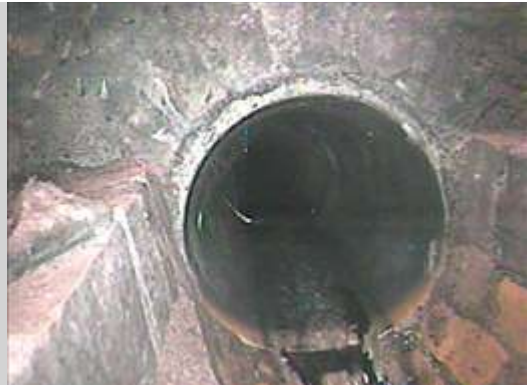
9 O'Clock Inflow

8 in. Circular Gravity Sewer
Pipe In @ 9 O'Clock

Pipe Material: **Clay** ☐ Pipe Lined

Invert Depth: **10.68** (ft.) Flow Characteristics: **Fast**

Infiltration: **None**

Pipe Seal Cond: **Sound**

Connects To: **House connection / Service line**
